QUALITY CONTROL REPORT

Independent LiDAR Quality Control Report

Calvert County Area of Interest

CATS II TORFP # 060B1400054
Digital High Resolution Aerial Photography (Orthophotography)

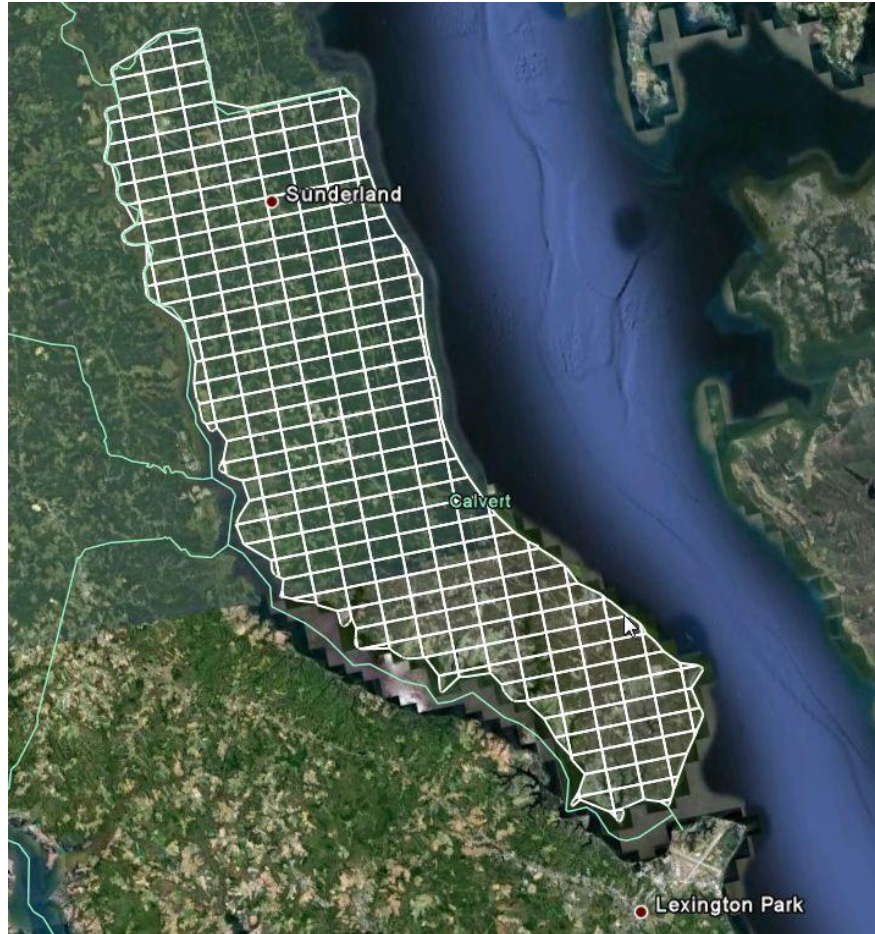
The project area for this task order consists of one, contiguous AOI denoted in the below figure as a white tile layout. Note that the LiDAR was clipped to the AOI boundary, resulting in partial tiles along the project boundary.

Figure 1 Project area of interest

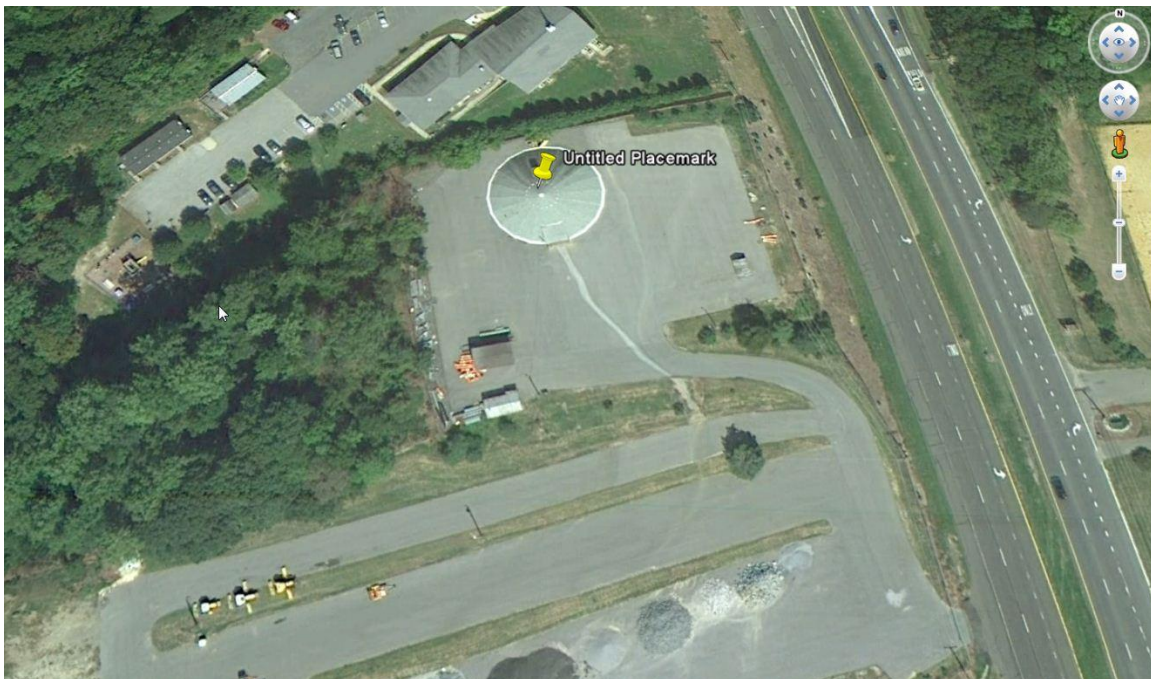
- Raw swath header records: the following issues were identified with the header records in the raw swaths delivered by Surdex –
 - A portion of the swaths delivered were produced using libLAS 1.2, which appeared to be the source of a header error where the headers displayed the incorrect number of points and the incorrect number of returns by point
 - The swaths with the above issue would not display correctly nor load into GeoCue
- 2 tiles in the AOI contained above-ground artifacts, which were found to be structures.

Figure 7 - TIN of tile containing building artifact in the ground points

Figure 8 - The above image in the same location clearly showing a road salt storage facility

A non-systematic problem was found during the detailed check of the LAS classified point cloud files. The check found a handful of LAS files that contained above-ground artifacts. Surdex redelivered the corrected tiles the same week when notified of the problem. URS subsequently checked the tiles to ensure that the corrections were made.
